QUALLA EASTERN BAND OF CHEROKEE HOUSING AUTHORITY TRIP REPORT

Assessment of Mold and Moisture Conditions

Final Report

February 23 - 24, 2005

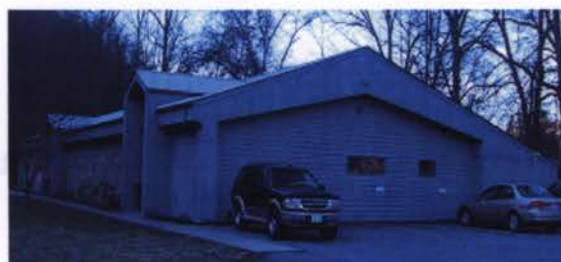
Figure 1: Courthouse

Inspection Number: 1-1
Address: Courthouse
Foundation: Slab-on-Grade
Construction: Furred-out block wall
Heat Type: Gas fired Forced air
Age: Varies with location

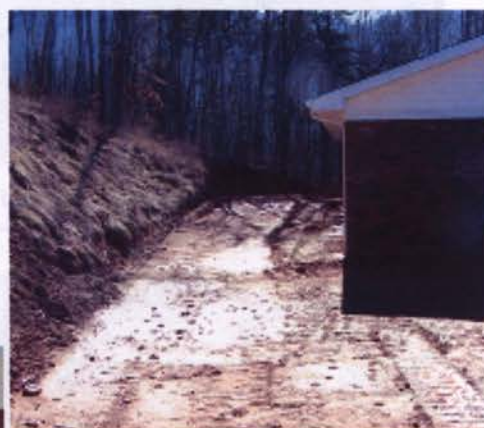
Figure 2: Drainage swale at rear of home; vinyl siding on gable end of home

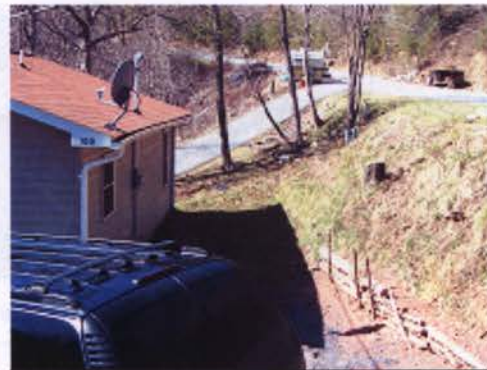
Figure 1: 109 Tooni Branch

Site Drainage and Rainwater Management: A hillside on the north side drained toward the west (Figure 1). The home did have a gutter system.

The wavy siding and substrate indicate a moisture problem. One possible source for the moisture was the hillside that drained toward the house. Water saturated the ground on this side of the building and filled the block cores of the stem-wall foundation. Water in the cores evaporated and found paths around the bottom plate and migrated up into the wall. As the OSB sheathing absorbed moisture, it swelled. Installation of a French drain between the base of the hill and the home to drain to the west may eliminate any future water problems, but the OSB will not return to a planar state.

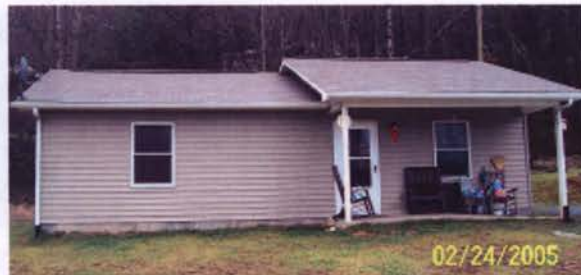
Figure 1: 110 Mary Jackson Road

Inspection Number: 2 -1
Address: 110 Mary Jackson Rd
Model Type: Ranch
Foundation: Slab-on-Grade
Construction: 2 x 4 Wood Frame
Heat Type: Unvented gas heater
Bedrooms: 3
Occupancy: 2 Adults, one child
Age: Unknown

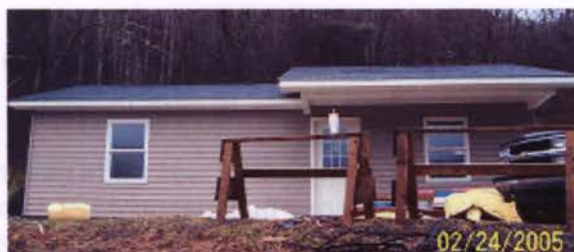
Figure 1: Unknown address

Mold and Moisture Conditions: This home under construction was almost completed. No mold was present.

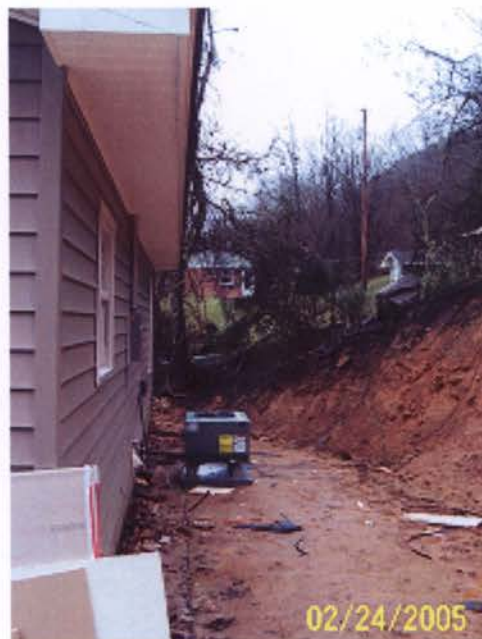
Figure 2: Hill at rear of home

3. Establish drainage from downspouts through rigid unperforated underground conduits that drain to daylight on the hillside in front of the home.
4. Give special attention to the finish grading at the rear of the home. Effective drainage of this area is important to keep the foundation dry so that it does not lead to wavy siding as seen on other homes.

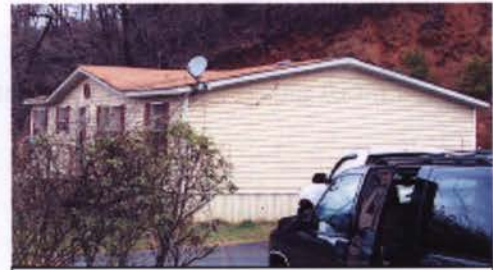
Figure 1: Smith Road

Inspection Number: 2 -4
Address: Smith Road
Model Type: Ranch
Foundation: Piers w/skirting
Construction: 2 x 4 Wood Frame
Heat Type: Gas Furnace
Bedrooms: 3
Occupancy: 2 Adults
Age: Unknown
